Characteristics of Indicators for Insulation Deterioration in 26 kV Generator Stator Windings

Power Generation Laboratory, Korea Electric Power Corporation (KEPCO) Research Institute, Dae-jeon, South Korea

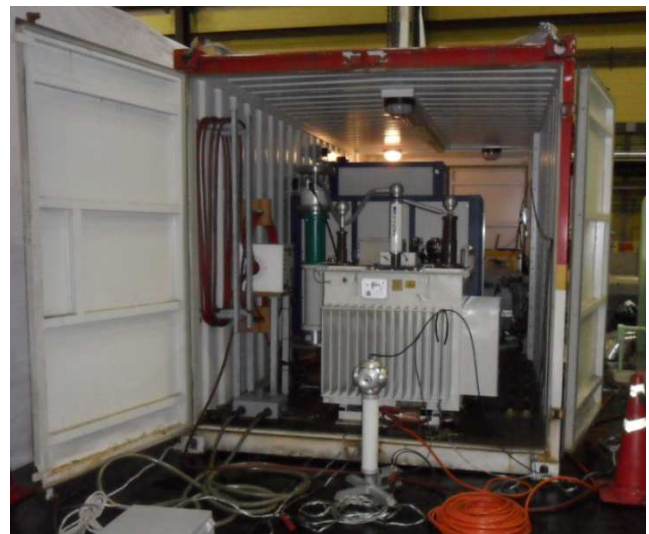
Figure 1. Construction of the insulation diagnosis and overvoltage test equipment.

This study discusses the off-line insulation diagnosis and insulation breakdown test on a 26 kV gas turbine generator stator windings that are operational for over 30 years. In the case of the off-line insulation diagnosis test, 5 kV DC current was applied to the generator stator windings by phase to measure the polarized index (Automatic Insulation Tester, AVO International) before applying high AC voltage. For the AC current, dissipation factor and partial discharge tests on the generator stator windings, schering bridge, coupling capacitor, and partial discharge measuring detector (PDD, Tettex Instruments TE 571) were used. The schering bridge comprises a power supply (HV supply, Type 5283), bridge (Type 2818), and resonating inductor (Type 5285). AC current was applied to the generator stator windings by connecting the schering bridge (Tettex Instruments) to it, and the coupling capacitor (Tettex Instruments, 4,000pF) filtered

After the completion of the off-line insulation diagnosis test, a overvoltage test was conducted to determine whether the windings acquired the minimum insulation dielectric strength required for the operation of the generator. In the case of the overvoltage test, the HV supply (50kV) and the bridge (Type 2819) were used to increase the voltage by 1 kV and permit 32.5 kV, 125% of the line-to-line voltage, for 1 min.

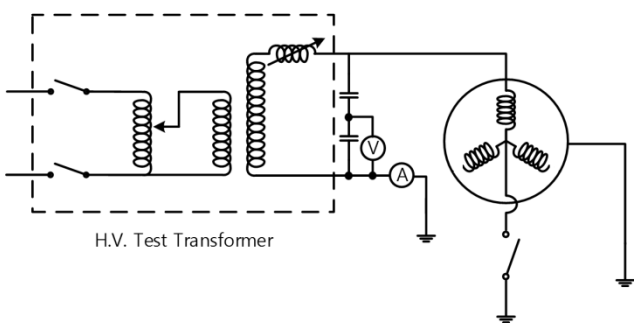
Figure 3. Circuit diagram for AC current estimation.

The AC current test determines the overall (average) insulation integrity of stator groundwall insulation. Shown in Figure 3 is the circuit diagram for performing the AC current test.

In this test, the neutral point of the steam turbine generator was separated, and AC voltage by phase was increased by 1 kV up to 1.25 times of nominal voltage at 26 kV, i.e., up to 32.5 kV, to measure the AC current. The test resulted in the AC current–voltage characteristics shown in Figure 4. Based on this, ΔI, a factor that shows the overall insulation integrity of the stator windings, was determined. ΔI can be derived from the following equations.

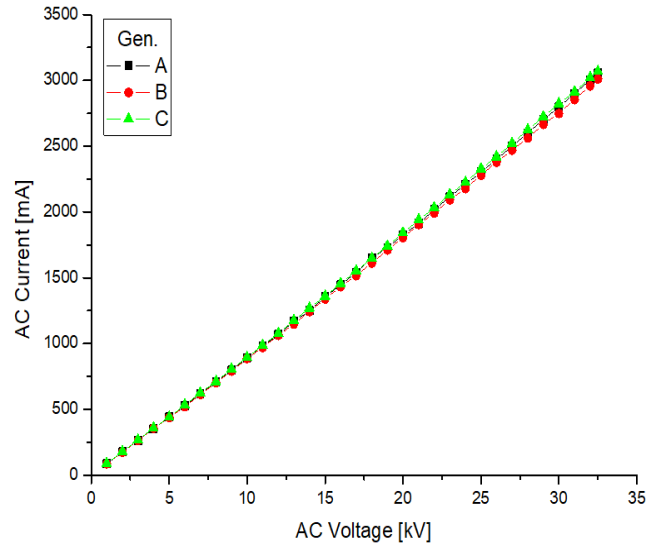
Figure 4. Characteristics of AC current vs. AC voltage in generator stator windings (Just after the occurrence of ground fault).

Meanwhile, the voltage at the point where the current surges is called current surge voltage, expressed as P_{i1} . As shown in Figure 4, the current surge voltage appearing at phases A, B, and C was 8.6, 8.7, and 8.9 kV, respectively. The AC current surge point was caused by the discharge within micro voids, which will be discussed later, and there appears slightly higher voltage than the partial discharge inception voltage or $\tan\delta$ surge voltage, and this shows that AC current surges not in the initial inception of the discharge but at the point when discharge occurs in the overall windings.

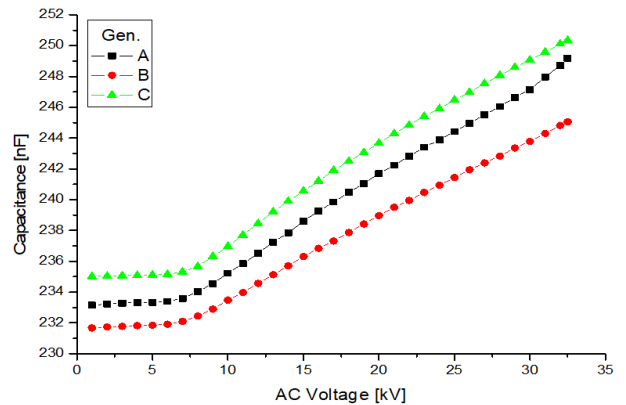
Figure 7. Characteristics of Capacitance in generator stator windings (Just after the occurrence of ground fault).

As shown in Figures 6 and 7, the $\tan\delta$ -voltage and C-voltage characteristics graphs, the dissipation factor and capacitance values tend to increase with the voltage.

Furthermore, the AC current at certain voltage clearly shows the lowest phase B because, as has been mentioned, the AC current was measured without the capacitance that corresponds to the coil part where the fault occurred. The comparison of the dissipation factor-voltage characteristics in Figure 6 and the capacitance-voltage characteristics in Figure 7 shows that they share similar patterns despite different physical properties.

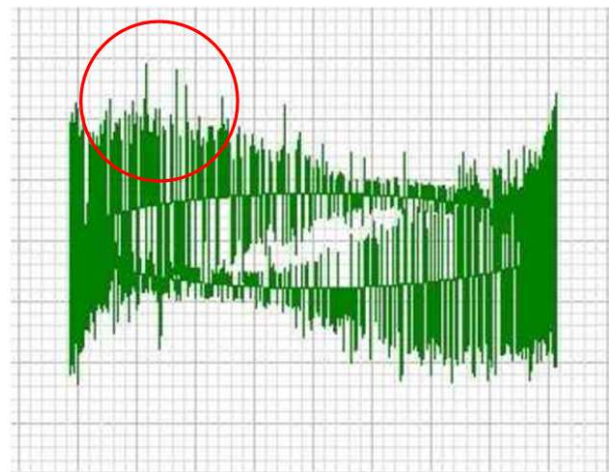
Figure 9. PD estimation (20,900 pC 15.0 kV).

Also, the partial discharge pattern mainly shows the conductor delamination discharge as shown in Figure 9. Considering that the partial discharge pattern two years ago was an internal discharge pattern, it is believed that as dramatic rise in Joule's heat attributed to the loss of cooling water (the surface temperature at the insulation material of the stator windings was 153°C), heat expansion occurred in the copper conductor, and the insulation material showed delamination as its heat expansion was lower than the copper conductor.
